Case Study

Customer: Transnet Rail Engineering – Sentrarrand

Requirement: Remediation resulting in rehabilitation of site

Product: Biosolve, Terrazyme, Aquazyme and Microbe Soil Treat

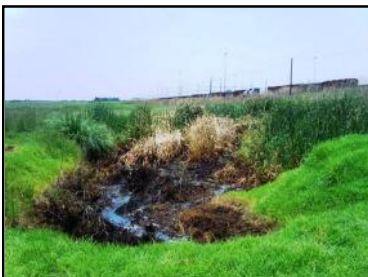
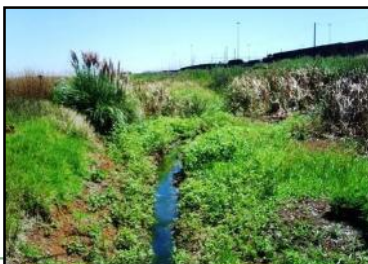
There were two diesel spillages of approximately 50 000 litres from the shunting yard that contaminated a total of 546m² of ballast stone and soil.

This spillage was made worse by the high rainfall and close proximity of a storm water drain that allowed the majority of the diesel contamination into the “Vlei” area and further into the wetlands

1. **Rail yard:** The immediate focus was to contain the existing spillage so no more storm water could be contaminated with the diesel. We also removed the highly contaminated soil and disposed of it into waste skips for safe disposal. The contaminated ballast stones we cleaned using our products Biosolve & Terrazyme, the remaining soil was treated with Biosolve, Terrazyme and Microbe Soil Treat.
2. **Storm water drains:** We utilized specialized High Pressure Drain cleaning equipment over 2 days to “flush out” any residual diesel and contaminated products that were residing in the drainage system.
